THE RECOVERY, RECONSTRUCTION, AND ANALYSIS OF YENİKAPI 14 (YK
14), A MIDDLE BYZANTINE MERCHANT SHIP FROM THE THEODOSIAN
HARBOR EXCAVATIONS AT YENİKAPI, ISTANBUL

A Dissertation

MICHAEL RICE JONES

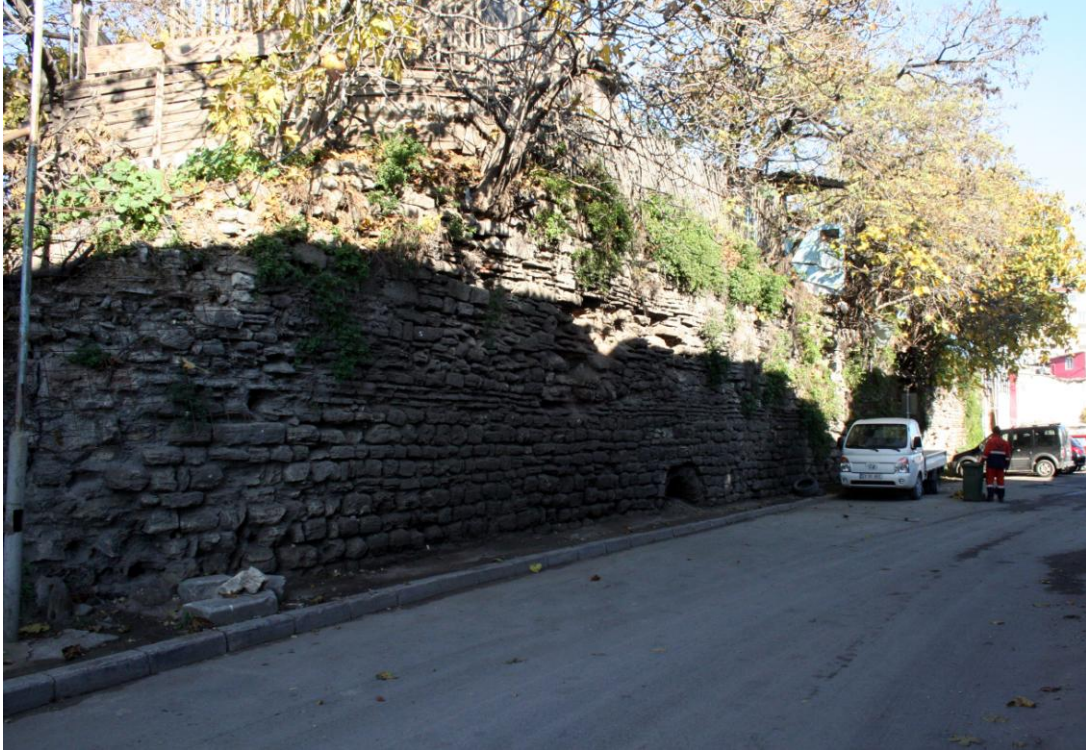
Figure 1.4: Section of the Byzantine harbor walls along the edge of the Theodosian Harbor, preserved along on Küçük Langa Street, Yenikapı, Istanbul, December 2008 (Photo by the author).

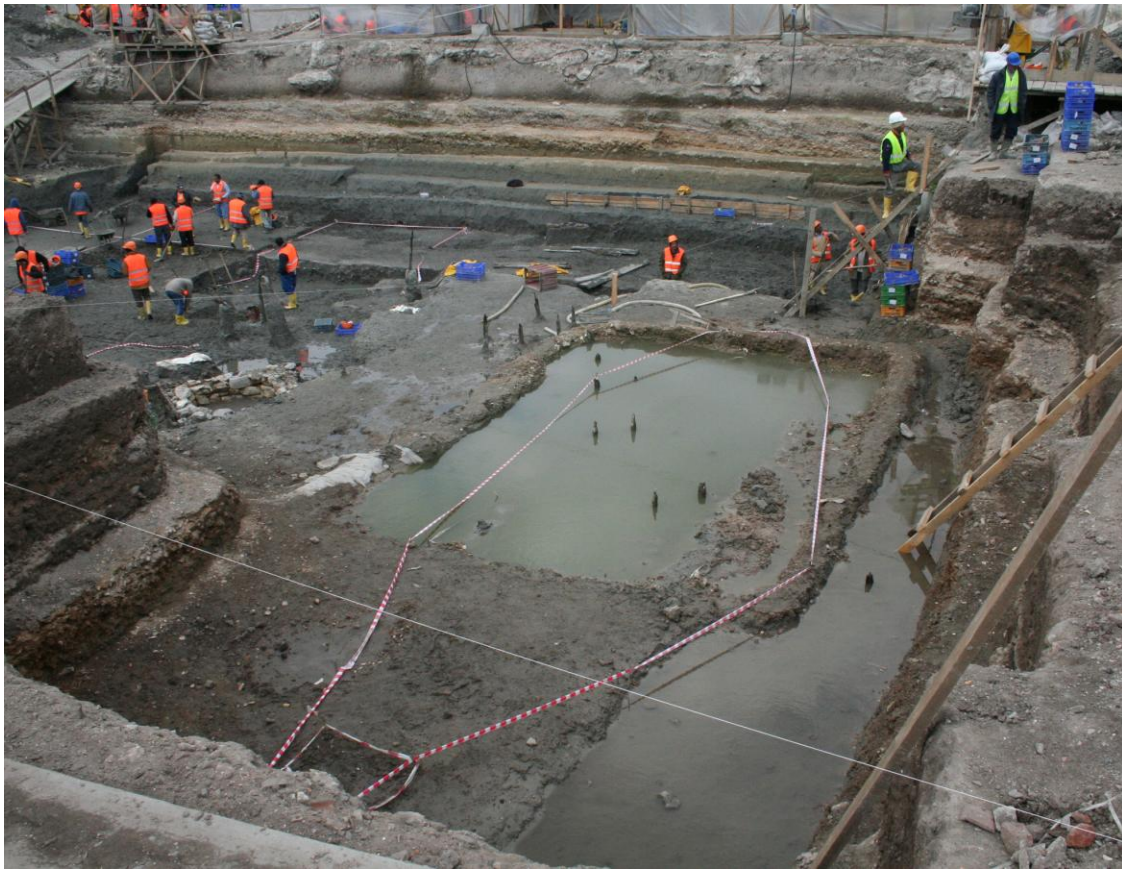
Figure 2.1: The YK 14 shipwreck site in March 2007, shortly before the beginning of its excavation. The plastic tape denotes the boundaries of the shipwreck. Note the later medieval dock pilings crossing the excavation area.

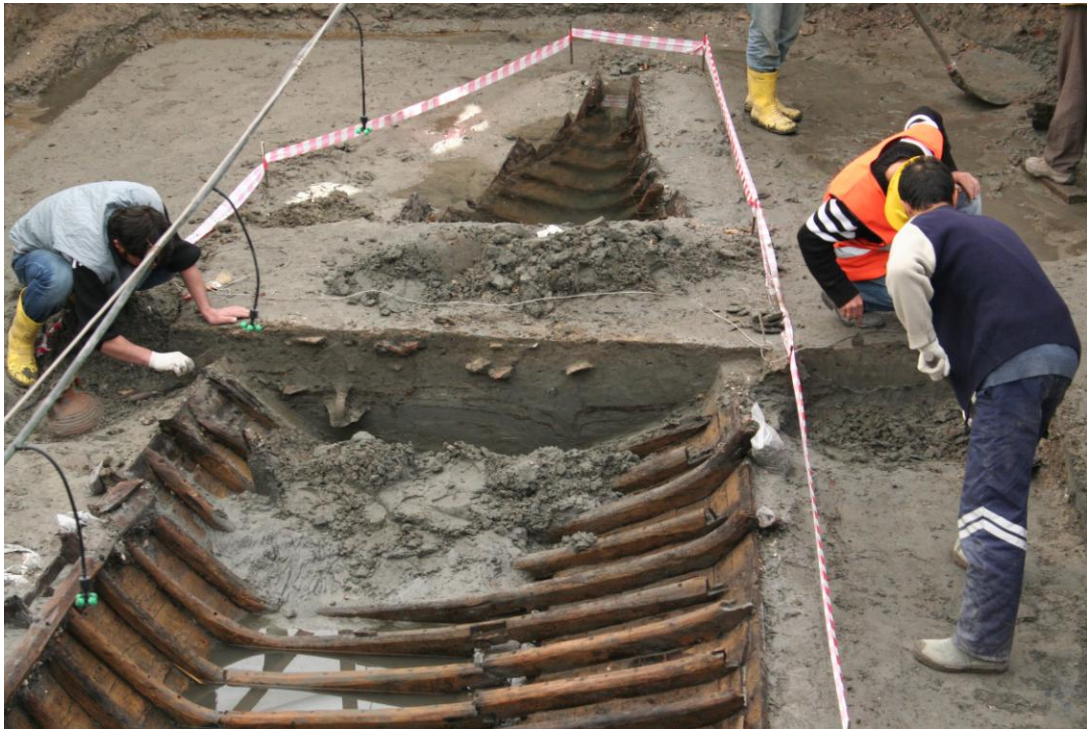
Figure 2.2: A baulk left across the YK 14 shipwreck during its excavation in April of 2007 shows the nature of the stratigraphic deposits in the shipwreck: gray sand, with some bands of darker organic material, and scattered pottery fragments, mostly from broken amphoras. These are similar to deposits observed outside of the ship.

During the final stages of excavation inside the ship, a baulk was left in one section of the hull in order to record the stratigraphy inside the shipwreck. Because the sediments inside the hull consisted of dense, packed sand and the hull timbers beneath were quite solid, archaeologists excavating the hull were able to stand or crouch inside the hull during the early stages of the excavation. However, once this material was removed, working from inside the ship was no longer possible without damaging the hull timbers. Much of the excavation, recording, and dismantling work over the remainder of the excavation was conducted from around the periphery of the shipwreck or on trestles set up across sections of the ship (**Figure 2.7**). The shipwreck site was formally handed over to the Institute of Nautical Archaeology (INA) team under the direction of Cemal Pulak on 27 April 2007.

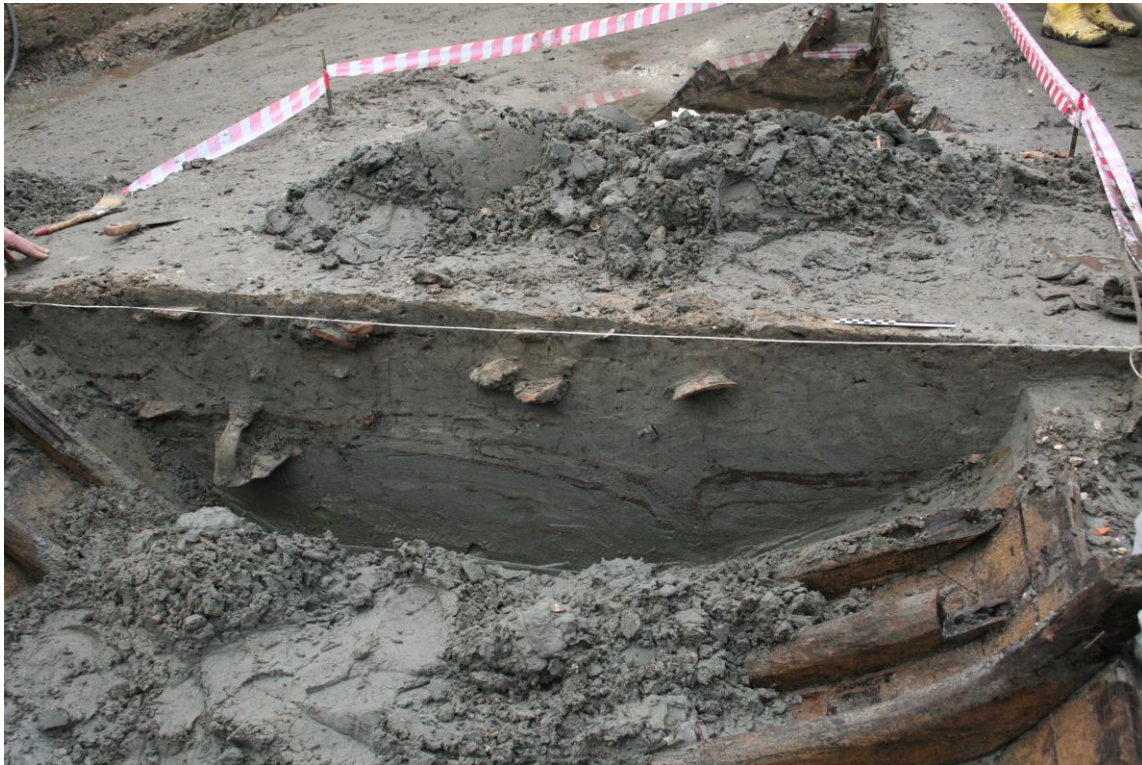
Figure 2.3: Detail view of the baulk left in the hull of YK 14 during excavation. Note that none of the pottery fragments are resting on the bottom of the hull, indicating that they were deposited in the hull some time after the sinking of the ship.

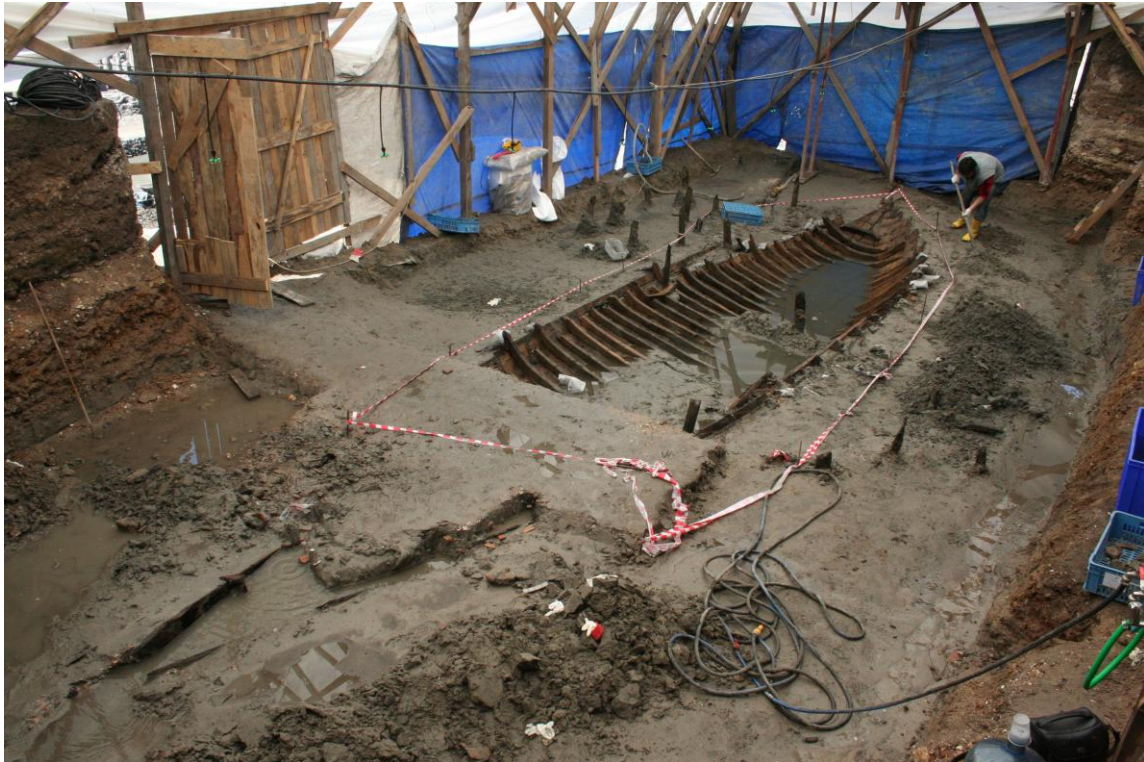
Figure 2.4: YK 14 during excavation, showing the excavation tent, water hoses and sprinkler system, and medieval dock pilings in situ.

Archaeologists from the Istanbul Archaeological Museums uncovered the YK 14 shipwreck between 28 March and 21 April, 2007. Work began with the erection of a tent around the shipwreck site (**Figure 2.4**). A greenhouse-style sprinkler system was installed inside the excavation tent in order to keep the waterlogged hull timbers from drying out during the excavation; drying causes shrinkage and distortion in waterlogged timbers.

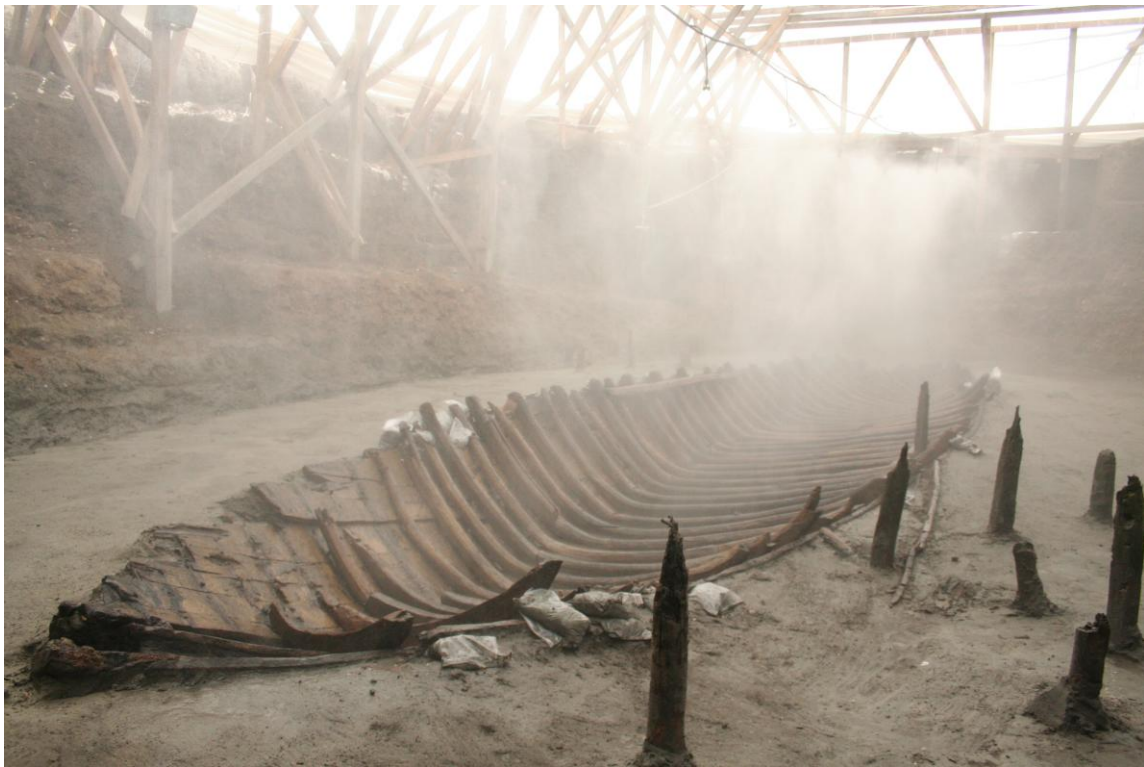
Figure 2.5: The sprinkler system in use on YK 14.

The sprinkler system was vital for preventing this damage to the hull, which necessarily remained exposed for several months during the excavation (**Figure 2.5**). During work hours when the sprinkler system was shut off, archaeologists sprayed the ship with a hose every few minutes in order to avoid damage to the wood from excessive drying. A sump was dug to the north of the shipwreck in order to drain excess water from the wreck pit. It consisted of a sump hole, into which a large, meter-deep wooden box was inserted to keep the surrounding sediments from collapsing. An electric pump for drainage was installed in the sump. Due to the drainage on the site at the time of the excavation, flooding of the excavation area by groundwater was not a significant

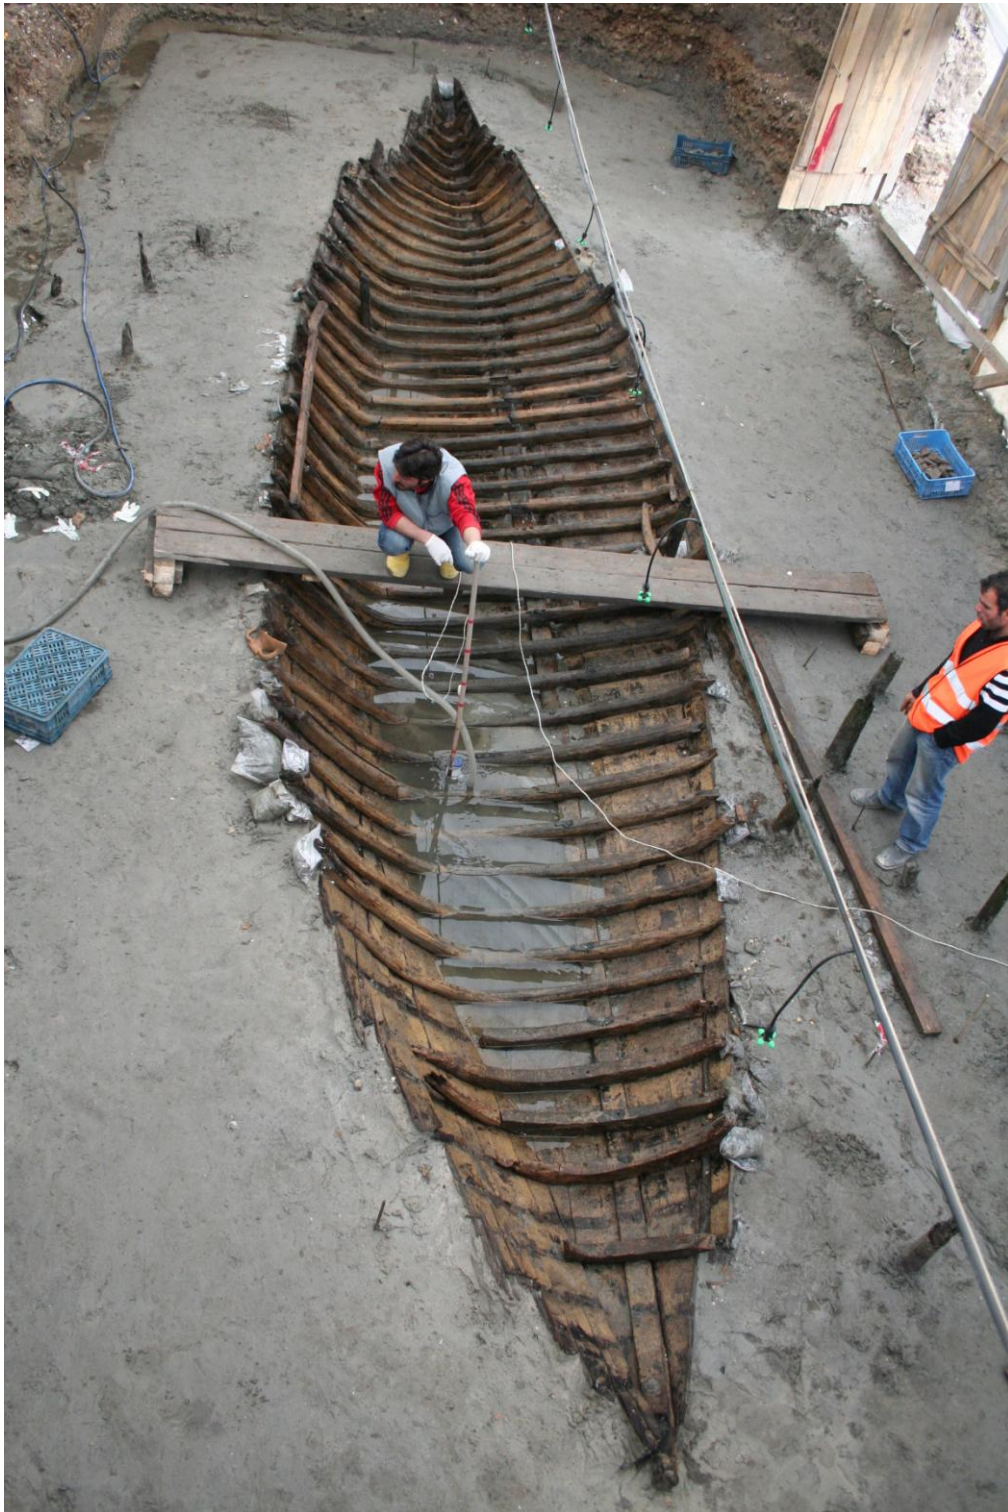
Figure 2.6: An archaeologist from the Istanbul Archaeological Museums uses a small electric pump to drain water from the ship's hull.

problem in comparison to some of the other shipwreck excavation areas at Yenikapı. When necessary, water collecting inside the shipwreck was removed with a small, portable electric pump (**Figure 2.6**). After several weeks, green algae began to grow on the wood in the lowest area of the hull; this growth was successfully removed by the spraying of a dilute water/bleach solution on the wood by the Institute of Nautical Archaeology's (INA) head conservator Asaf Oron. Since it was used sparingly, this procedure had no adverse effects on the hull timbers.

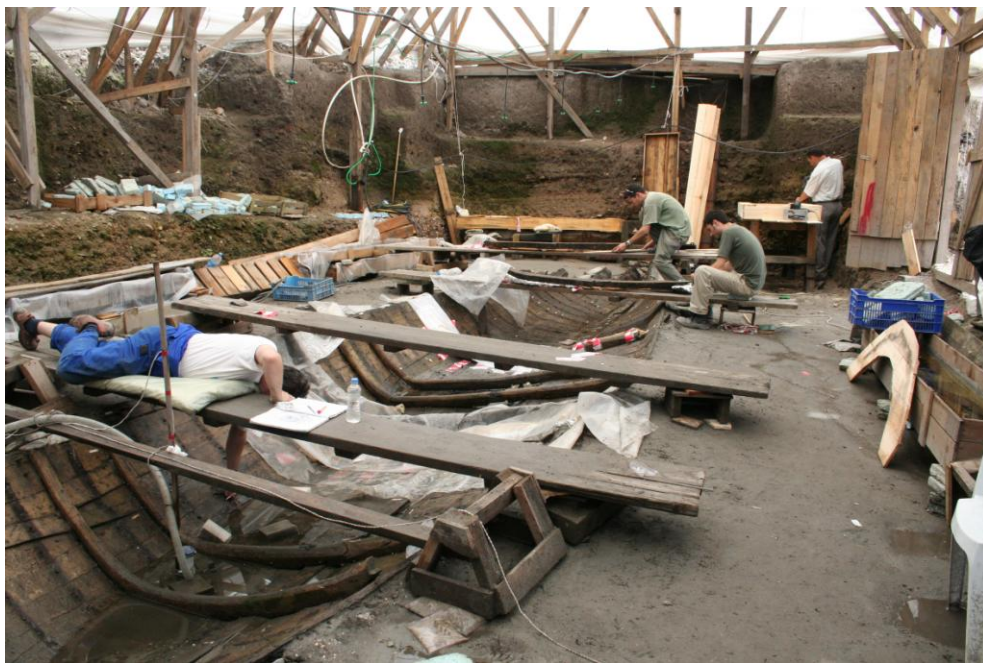
Figure 2.7: In order to work on the inside of the hull without damaging the hull timbers, trestles were set up across the shipwreck. Here, several archaeologists of the INA team work on the field documentation and removal of frame timbers from the hull (May 2007).

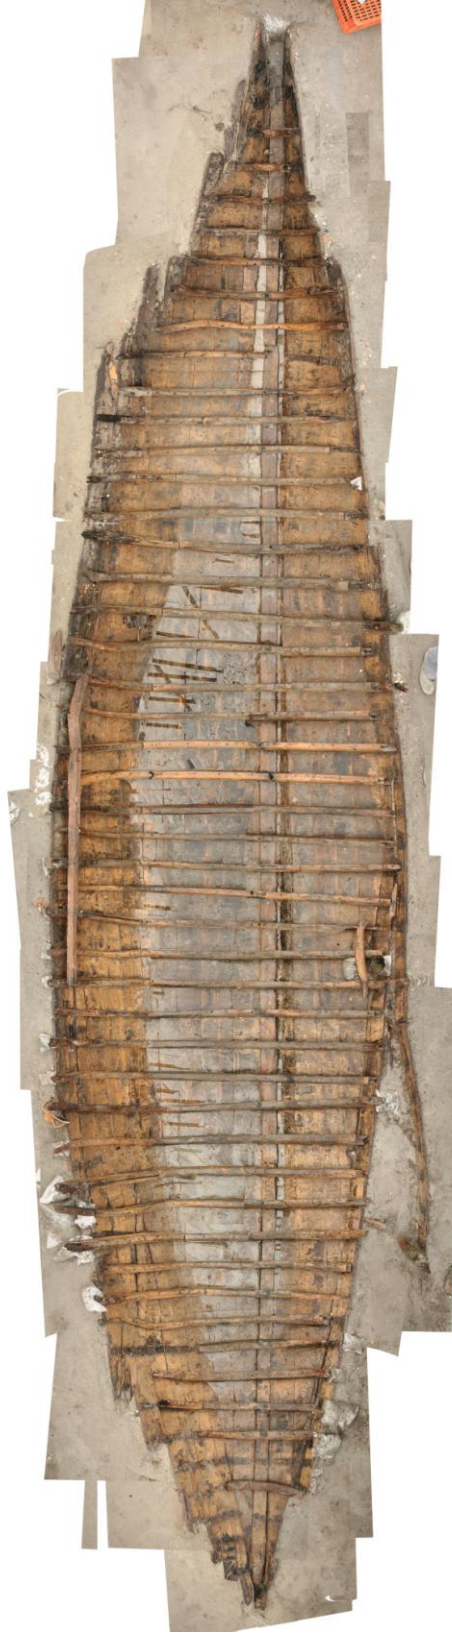
Figure 2.8: Photomosaic of YK 14 by S. Matthews, April 2007.

After the initial excavation of the shipwreck was complete, overall and detail photographs of the hull were taken, as well as detailed notes on construction features of the vessel. A photomosaic was made in Photoshop by INA archaeologist Sheila Matthews from a series of overview shots taken vertically from around the periphery of the wreck (**Figure 2.8**). The photomosaic photographs were not taken with a photogrammetry apparatus, and so are not suitable for obtaining detailed measurements of the wreck, but were intended for documenting an overall view of the ship's features and for producing preliminary site plans to assist with the documentation of the hull during the excavation.²¹⁸ An outline plan of the hull timbers based on the photomosaic of the wreck was produced by Matthews in Photoshop; this plan was used during the excavation for taking notes and making study diagrams (**Figure 2.9**).

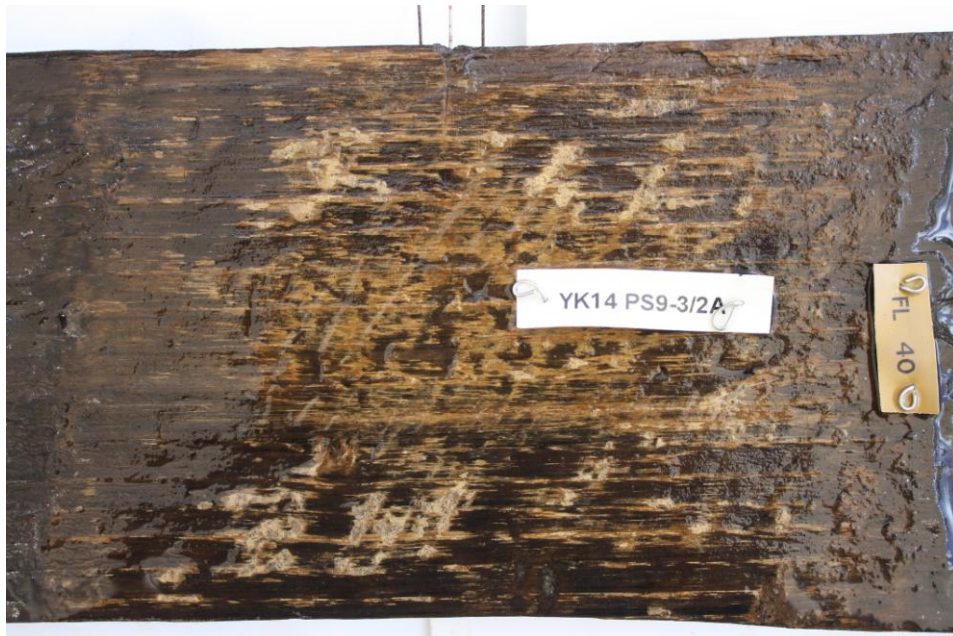
Figure 2.10: Plastic Dymo labels on a hull plank. The labels were fastened to the plank using pins made of stainless steel wire. These labels were replaced with embossed stainless steel labels during cataloging in order to prepare the timbers for conservation treatment in PEG (polyethylene glycol).

After the photomosaic and outline plan of the ship were completed, the outline plan was used to assign labels to each timber on the wreck site. Planks were labeled with temporary plastic labels made with a Dymo LetraTAG label maker (**Figure 2.10**).

These labels are white with black text, a useful color combination for timber labeling on shipwrecks because the label text is fairly legible in detail photographs of the hull. After the excavation, the plastic Dymo labels were replaced with embossed stainless-steel labels made with a Rhino M1011 label maker in preparation for conservation

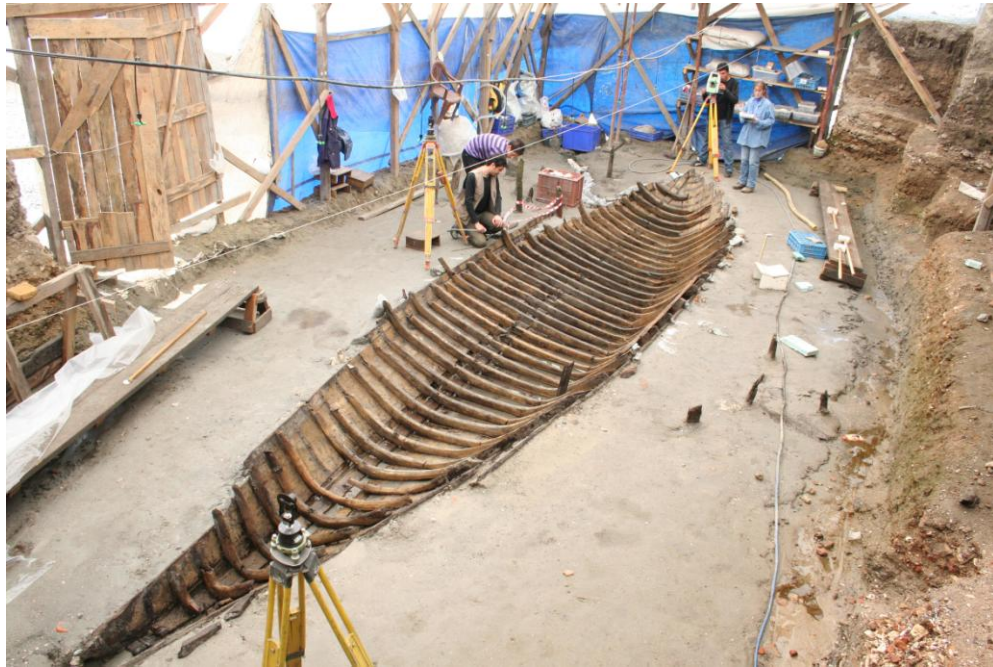
Figure 2.11: The tripods around the ship serve as datum points for total station mapping of YK 14.

The shipwreck was mapped in situ using a total station and technicians provided by the surveyor Sadık Demir of İmge Harita İnşaat. Demir’s team worked under the direction of Sheila Matthews in mapping the shipwreck between 28 April and 10 May, 2007, with additional mapping of planking features after the removal of the frames from 1-6 June, 2007. The total station is an electronic theodolite that measures distances using an infrared or laser light beam and stores measurement data.²²¹ Total station mapping requires the recording of three stationary datum points set up on level tripods, whose positions are measured by the total station device itself. The total station measures the exact distance from the datum points to specific points on the shipwreck using an a built-in electronic distance measuring device (EDM), which measures distances from a datum point using a laser. The laser can be fired at either a specific point indicated by an assistant with a pointer, or with a reflector with an embedded level, which is used for points that are blocked from the EDM operator’s direct line-of-sight. (**Figure 2.11**). Each point is assigned a set of x-y-z coordinates by the total station. Matthews developed a set of charts, sometimes supplemented by sketches in more complex areas, to identify the specific points or groups of points as features of the shipwreck, such as timber edges, plank seams, and fasteners (**Figure 2.12**).

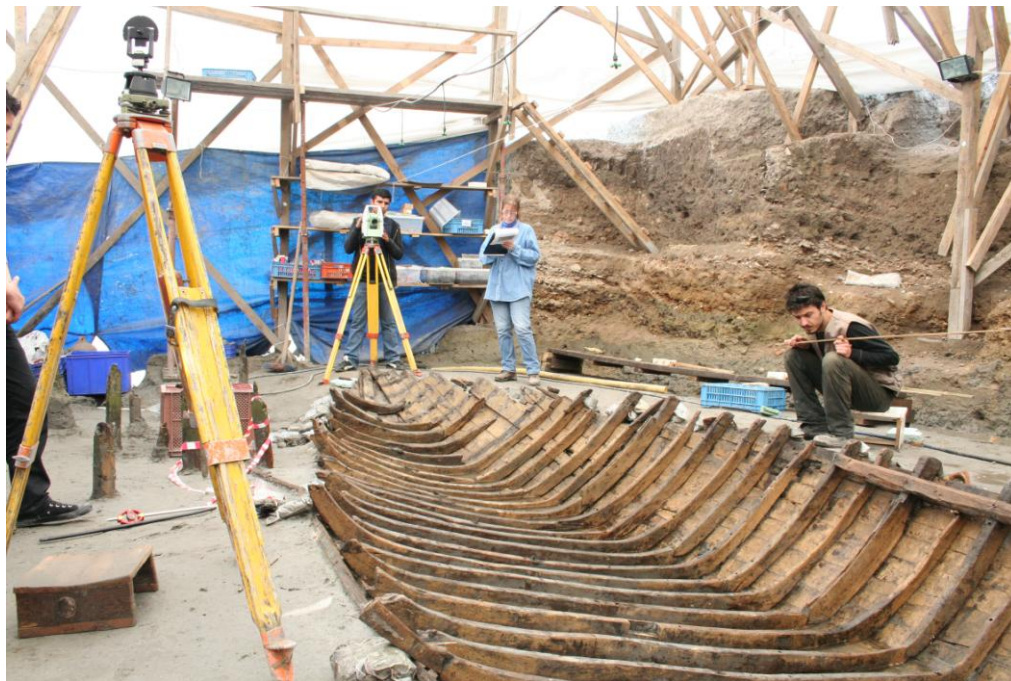
Figure 2.12: Total station mapping in progress.

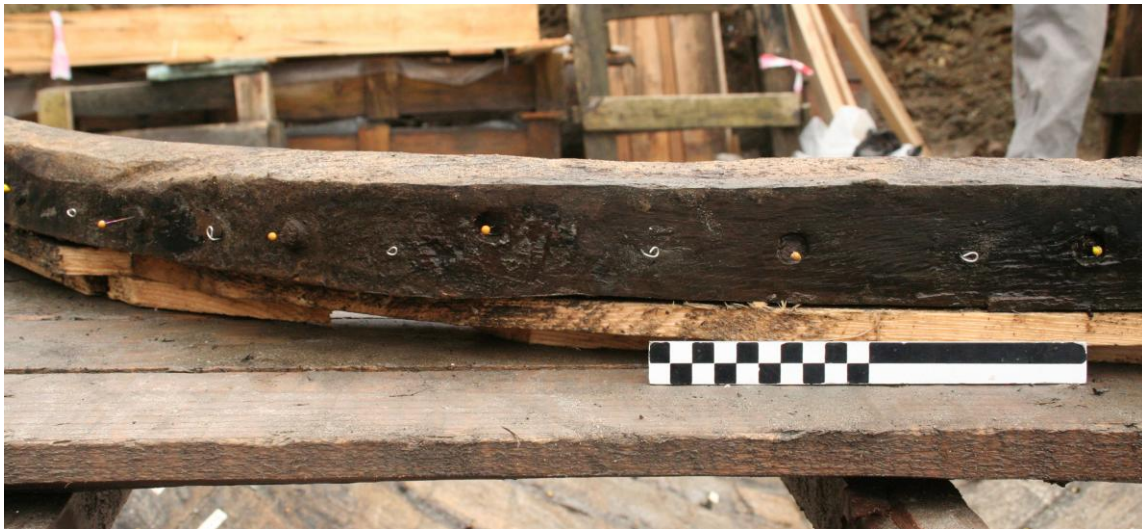
Figure 2.14: A section of Frame timber FL 18's outer face after removal from the hull, with plank seams and fasteners marked with pins. Fasteners were marked in order to match the fasteners on the frame to the corresponding ones on the planking after dismantling: yellow pins were used for treenails and blue pins were used for nails.

To remove large frames, first a trestle was set across the ship next to the location of the frame to be removed. After the frame fasteners were cut or broken through, the fasteners or their holes on the outer face of the frame, as well as on the planking, were cleaned and marked with steel pins; the outer face of the frame and the fastener holes in the planking at that position were then photographed (**Figure 2.14**). These photos were used for reference later during the cataloging and reconstruction stages.

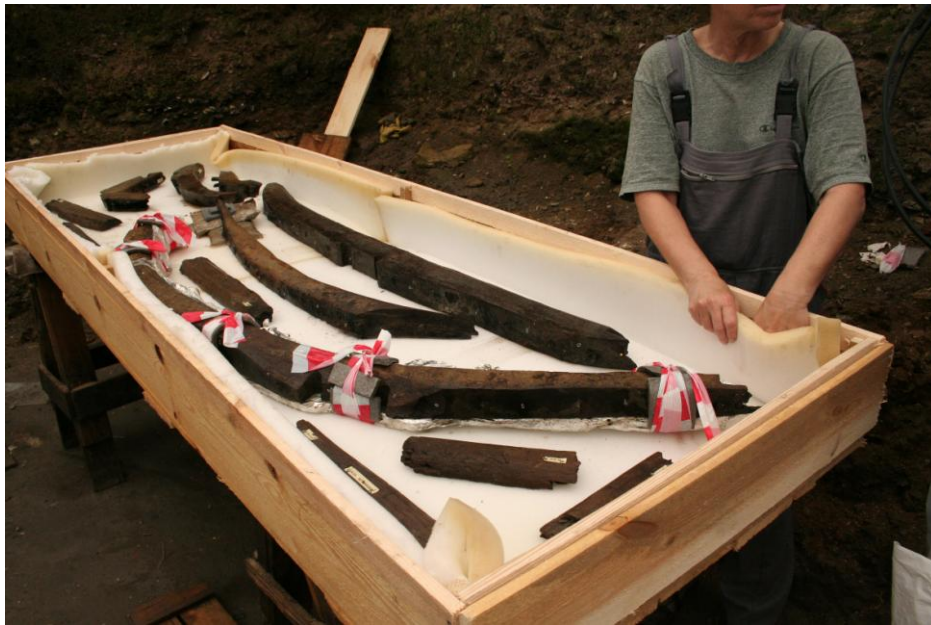
Figure 2.16: Frame timbers in a foam-lined crate awaiting packing and shipment to the INA Bodrum Research Center.

After the documentation of a frame and its corresponding planking fasteners was completed, frame timbers were packed in wooden crates lined with 2.5 cm-thick foam sheets in preparation for transport to the Institute of Nautical Archaeology's Bodrum Research Center (BRC) for further documentation and conservation treatment (**Figure 2.16**). The crates for frames were made in two sizes to accommodate different-sized frame timbers: 2.5 m long, 82 cm wide, and 20-25 cm high for large frames, and 2.43 m long, 50 cm wide, and 18-20 cm high for smaller frames. Usually, several frame timbers could be packed in a single box, and smaller foam pieces were often packed between the timbers to prevent damage while in transit. This was generally sufficient for those frame timbers that did not have significant curvatures in more than one dimension.

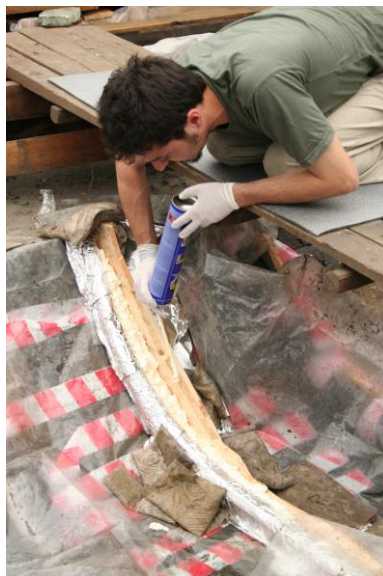
Figure 2.17: Polyurethane foam was injected into the gaps between a floor timber and the wooden timber mold. The floor timber itself was wrapped in two layers of aluminum foil to prevent the polyurethane from adhering to the floor timber, while the plastic was spread between the outer face of the floor timber and the hull planking.

assembled mold base was also propped in place as closely to the floor timber as possible. Plastic ties were inserted through the space between the floor timber, the mold base, and the planking so that the floor could later be tied to the mold; strips of foam were added between the ties and the frames to protect the frames' surfaces. In order to protect the hull's interior surfaces from any stray polyurethane drops, a layer of plastic was inserted between the floor timber and the planking. Two layers of aluminum foil were inserted into the space between the mold and the floor timber in order to prevent the polyurethane foam from adhering to the floor timber. The polyurethane was then injected into the gaps between the mold and the frame timber and allowed to harden. Finally, the plastic was removed; the plastic ties and were used to fasten the floor timber to the mold and the floor timber was removed from the ship.

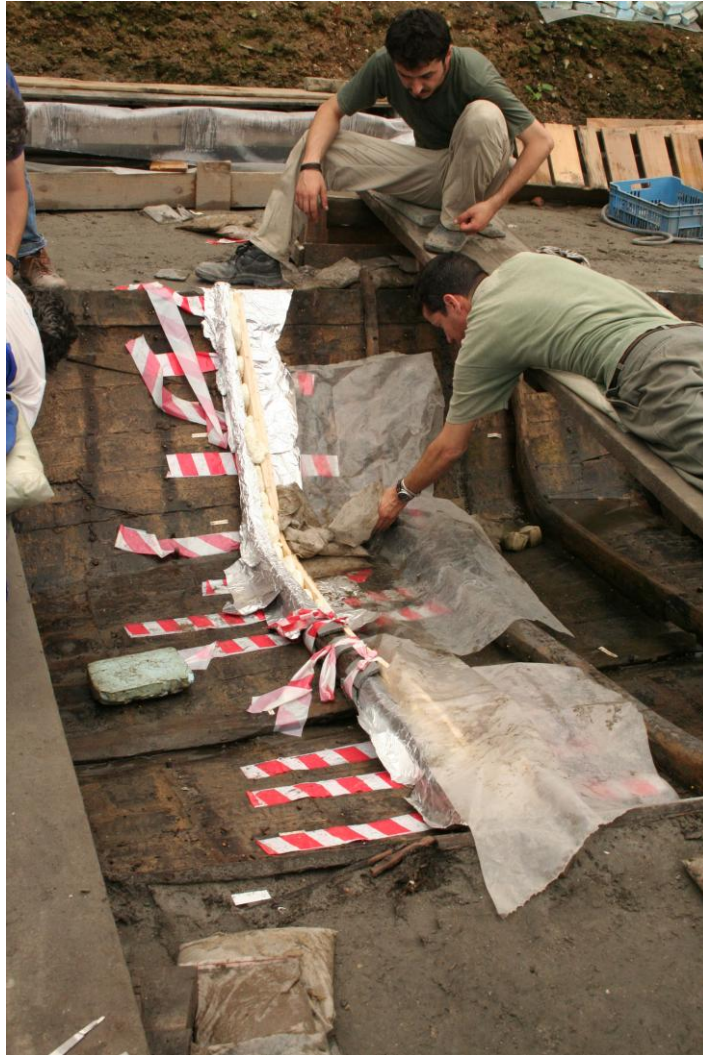
Figure 2.18: A floor timber being prepared for removal from the hull. After the polyurethane hardened, the floor timber was tied to the frame mold with plastic ties and lifted from the shipwreck.

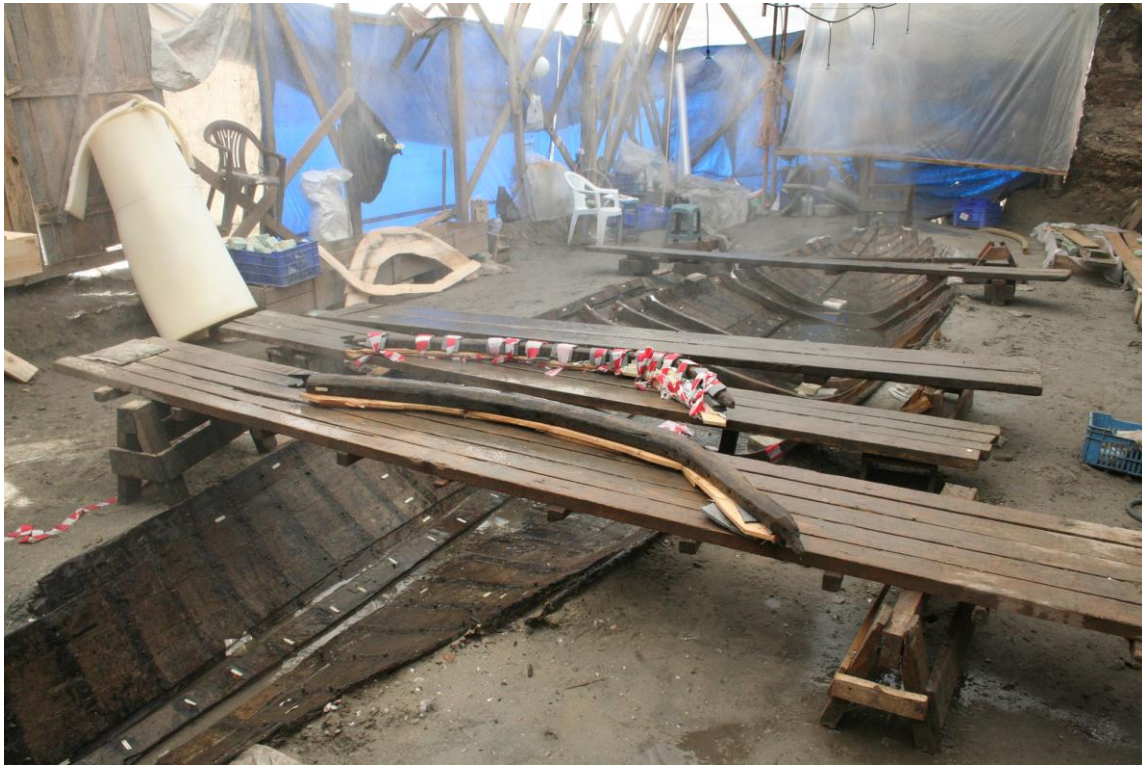
Figure 2.19: Two floor timbers on molds. The timber on the trestle in the foreground is still being documented, while the timber behind it is secured to its mold and is ready for packing.

This method proved quite successful for removing large frame timbers from the hull and transporting them to the Bodrum Research Center safely. The molds were very convenient for moving the frames during the excavation and later documentation at the BRC. They also proved particularly useful during the creation of 1:1-scale drawings of the different faces of the frames, since the mold kept the timber at the same orientation throughout the drawing process. In all, 11 of the 45 floor timbers from the ship were removed with these molds.

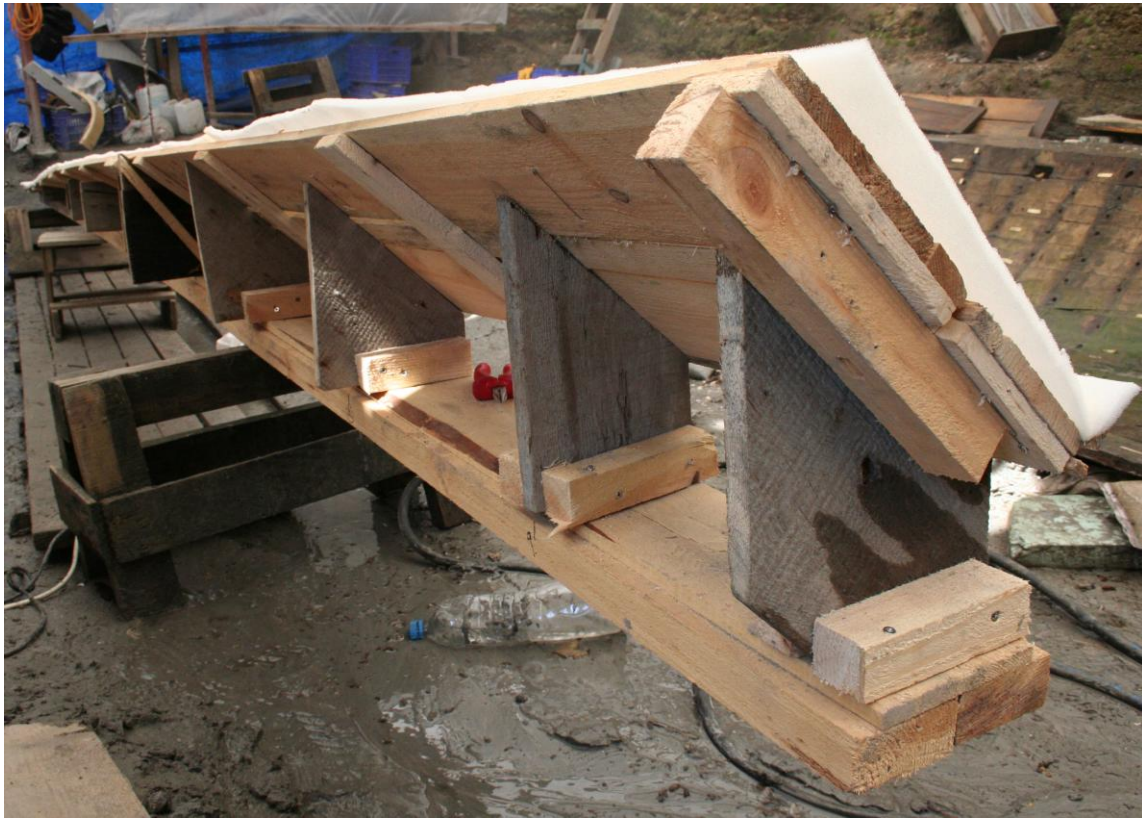
Figure 2.21: Detail of a plank mold constructed for a curved plank during the excavation.

The molds for curved planks were built by measuring the curvature of the pieces, either by taking offsets by hand or by the preparation of a diagram for the construction of the mold based on total station data of the mapped hull. Since there was typically a margin of error using either method, (often due to the ‘twist’ of a plank closer to the endposts of the vessel), 2.5 cm-thick foam was fastened to the mold surface in order to cushion and support the plank. The foam also provided significant friction, which prevented the planks from sliding off the molds. The timber molds were built with a base of 5 x 10 cm beams, onto which the upright supports for the mold were fastened at specific intervals (**Figure 2.21**). This method of construction was time-consuming and often involved some improvisation, but overall it proved very effective for preserving the timbers intact, and for allowing them to be moved with relative ease (considering their size), both on the excavation site and during later documentation at the BRC.

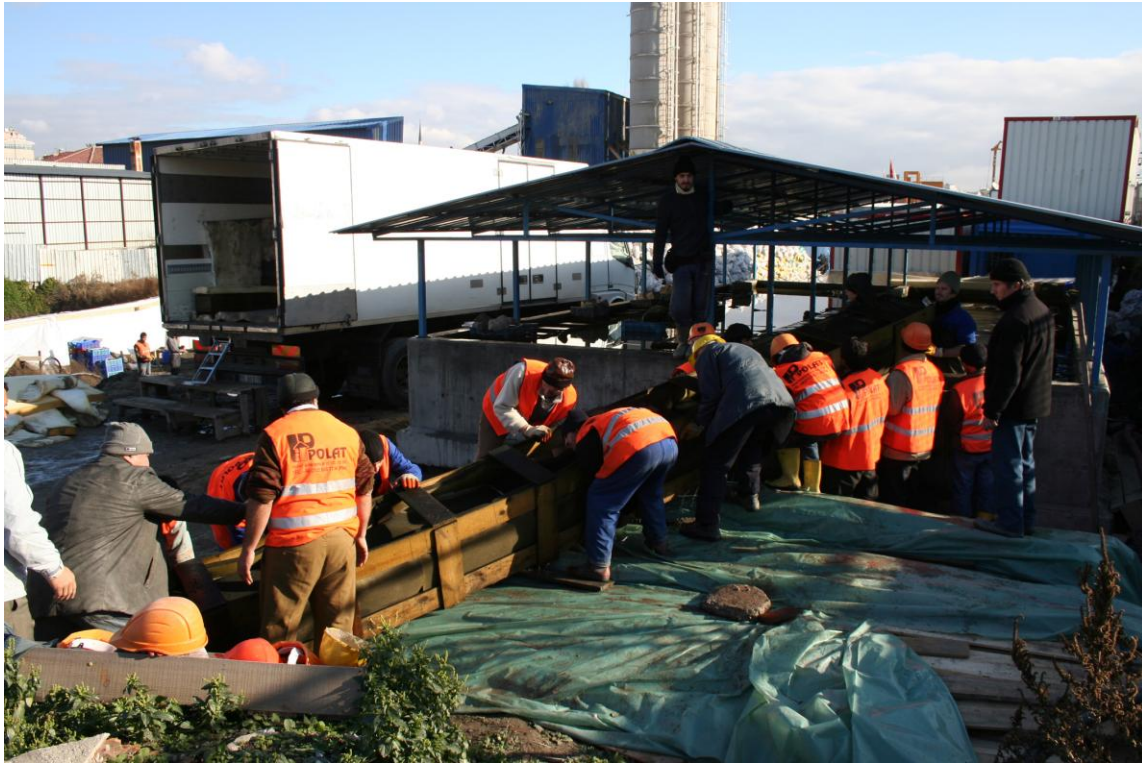
Figure 2.22: The moving of a large plank box from freshwater storage tanks at the Yenikapı site to a cargo truck bound for INA's Bodrum Research Center (BRC), January 2008.

After a plank was removed and placed on its custom-built mold, it was secured to the mold with plastic tape and covered with a sheet of 2.5 cm-thick foam, which protected the plank by keeping moisture in; then, the plank-mold assembly was placed in a wooden crate built for this purpose. The crates were transported to concrete freshwater storage tanks on the site until shipment to INA-BRC could be arranged (**Figure 2.22**). The crates required weighing down with stones and bricks to prevent them from floating and capsizing, but after several months to a year in the water storage tanks, most timber crates were no longer buoyant and the weights could be removed.

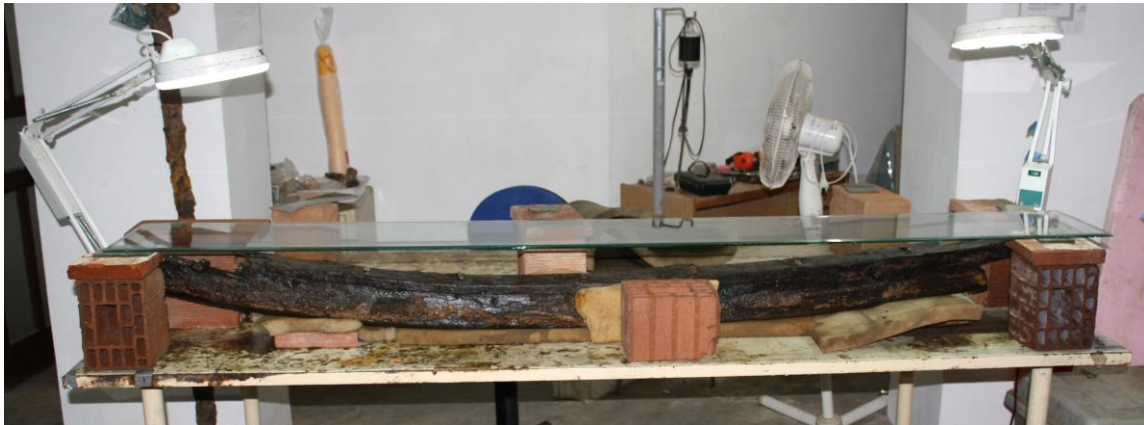
Figure 2.23: Keel timber Keel 1 set up for drawing on glass in the wood conservation laboratory at the BRC.

taking cross sections.²³⁰ Curved timbers such as the frames were first drawn using permanent markers on a glass pane; when these drawings were complete, a ‘clean’ final copy was made by transferring the drawing on the glass to PVC plastic, and colors and other notes were added later.²³¹ Most of these drawings were made with the glass positioned over the timber (**Figure 2.23**). However, the curvature of many of the ‘L’- or ‘V’ shaped floor timbers from YK 14 were too great to record in this manner, as it was too difficult to prop such large frames in this way without damaging them. For these timbers, the glass was set up at a 90° angle from the face being drawn, and lights on extendable arms were clamped to the table over the glass (**Figure 2.24**).²³² The positioning of the lights used in this type of scale drawing is crucial; the reflection of the drawer’s pupil in the glass ensures that the feature he or she is tracing is perpendicular to the glass. For this reason, two lamps with adjustable armatures were used for each drawing. This method is quite effective, and drawings made in this way which were checked against measurements of the actual frame timbers and were found to be accurate.²³³

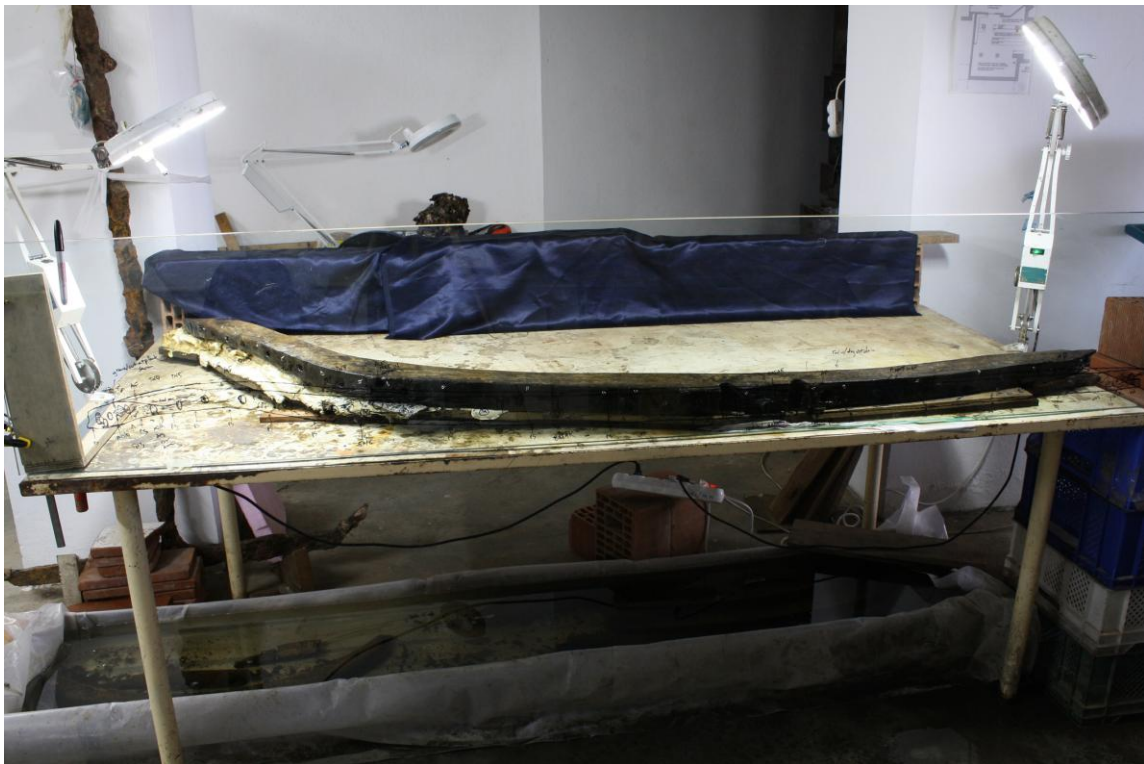
Figure 2.24: The outer face of FL 20, a large, curved floor timber supported on a frame mold, being drawn directly on glass.

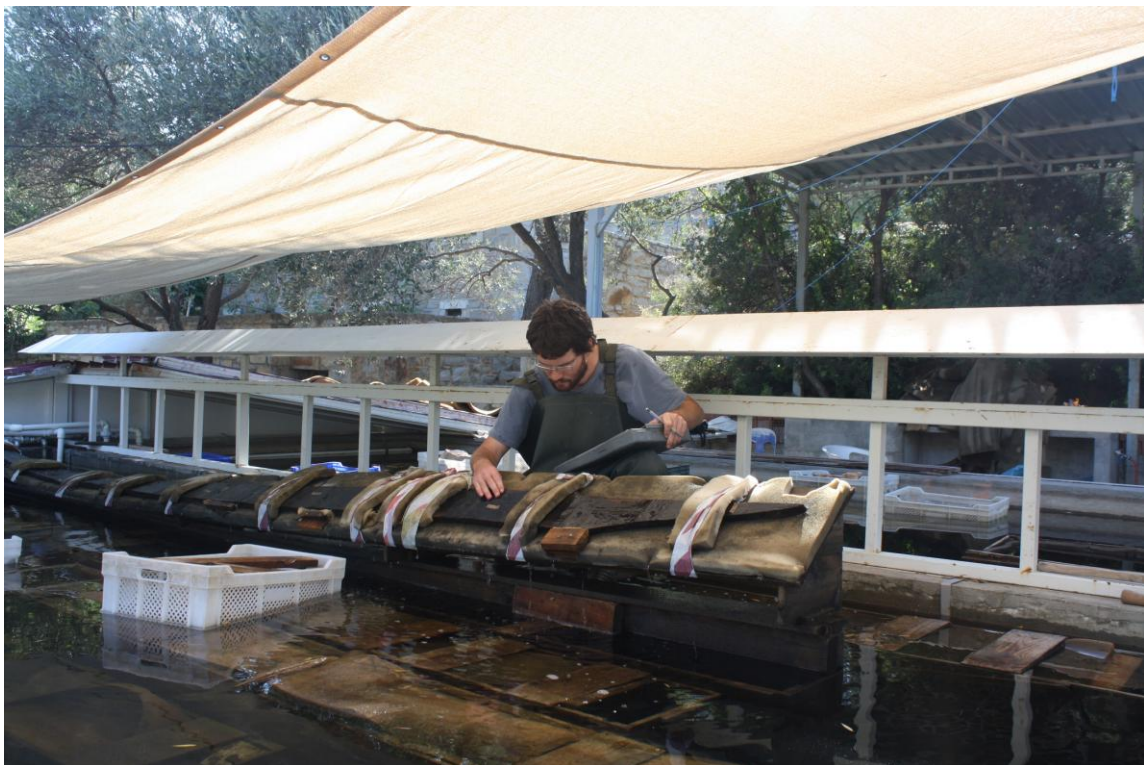
Figure 2.25: Timber cataloging at INA-BRC. The large planks and keel timbers were cataloged in outdoor water storage tanks (Photo by R. Ingram).

While the ship's frames and smaller hull planks could easily be handled by one or two individuals using wooden pallets, documenting the larger hull timbers presented greater logistical challenges. Large timbers on custom-built plank molds were too heavy to remove from the outdoor wet-storage tanks. In order to catalog these large timbers, the plank molds were removed from the timber crate and propped above the water level inside the storage tanks (**Figure 2.25**).

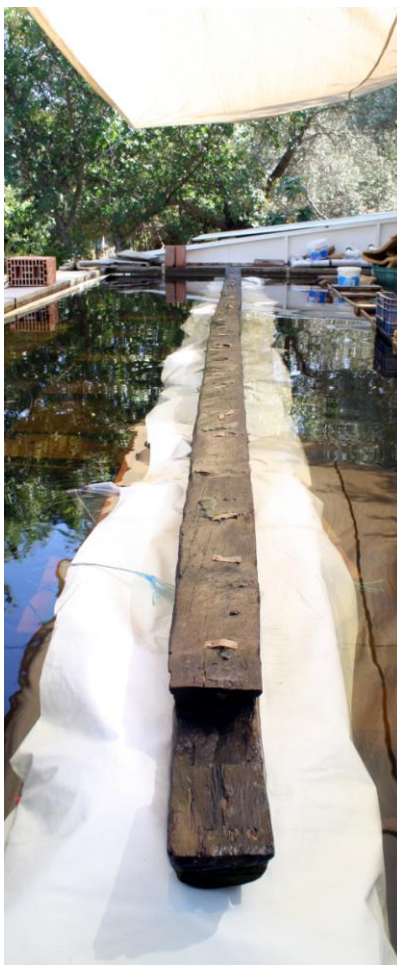
Figure 2.26: Keel 2, the main keel timber of YK 14, set up for photography of its inner face. The white photographic background material was inserted beneath the keel while it was still submerged in the holding tank.

The documentation of two of YK 14's large keel timbers, Keel 2 and 3, also proceeded in the timber storage tanks. The 6.55-meter main keel timber, Keel 2, did not require a mold during its lifting and removal from the site, but due to the weight of the timber, the crate for the timber was built with a bottom heavily reinforced with 5 x 10 cm timbers. For the drawing and cataloging of this piece, the sides of the crate were unscrewed and the timber was propped with bricks in the timber tank on top of other large timber crates (**Figure 2.26**). Keel 3, although smaller, was in a heavily reinforced crate which could not easily be dismantled. This timber was cataloged on a reinforced 4-meter pallet built from marine plywood and 5 x 10 cm beams for the cataloging of keel timbers from the
